**SIXTH LAKE DAM**  
HAMILTON COUNTY, NEW YORK

**NY 318**  
**PHASE I INSPECTION REPORT**  
**NATIONAL DAM SAFETY PROGRAM**

CONVERSE WARD DAVIS DIXON  
CONSULTING ENGINEERS  
91 ROSELAND AVENUE, P.O. BOX 91  
CALDWELL, NEW JERSEY 07006

11. CONTROLLING OFFICE NAME AND ADDRESS		12. REPORT DATE	
New York State Department of Environmental Con- servation/ 50 Wolf Road Albany, New York 12233		21 September 1978

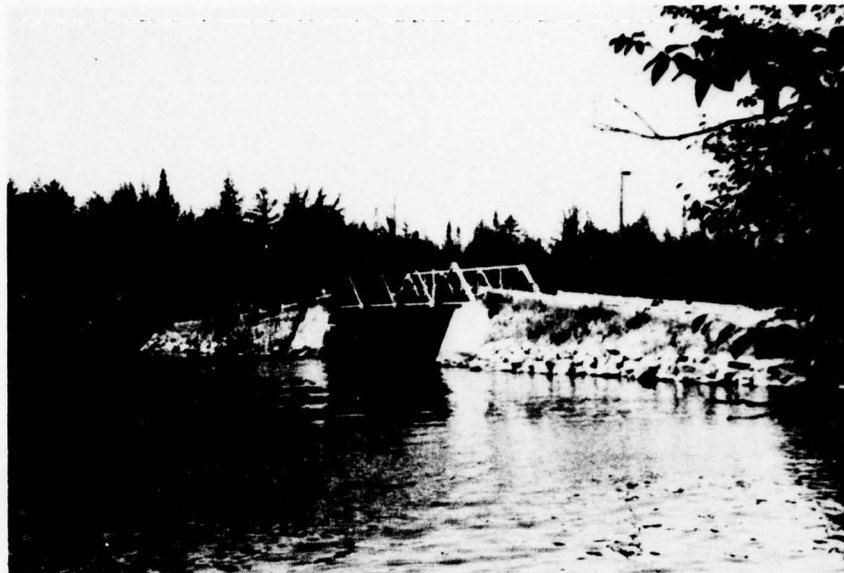
Sixth and Seventh Lakes are at the same elevation with the connection occurring through a free inlet beneath a steel truss bridge (Fig. 3, Appendix D). The opening is approximately 35 feet wide from abutment to abutment, and the distance from the bottom of the bridge steel to the top of water was approximately 11 feet on the day of the inspection. Judging from the high water stains on the bridge abutments, this structure does not appear to seriously constrict flow from Seventh Lake to Sixth Lake.

FIGURE 3. JUNCTION OF SIXTH AND SEVENTH LAKES

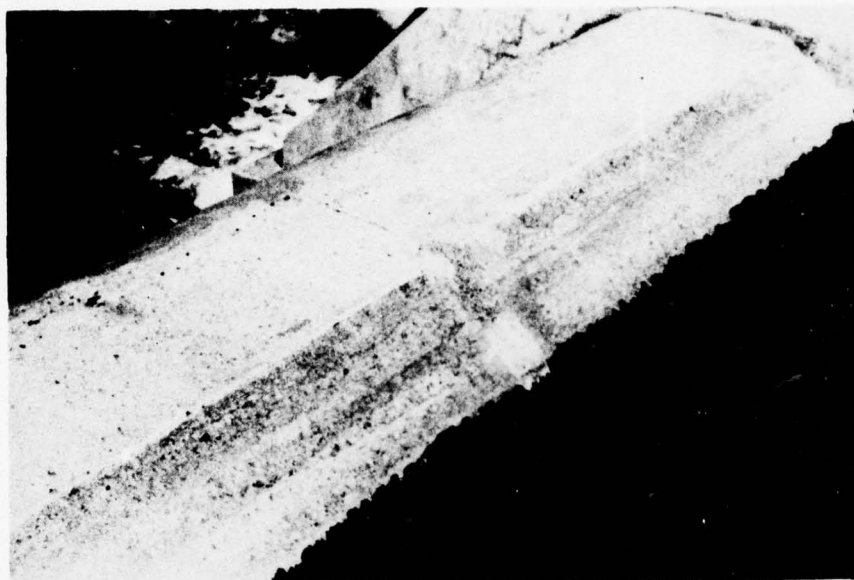
On the day of the inspection, there was no flow over the spillway section. The crest appeared to be in generally good condition, with signs of only minor erosion. It was apparent that the spillway face, and especially the structural joint at the center of the spillway, had been patched recently (Fig. 5, Appendix D). The left side wall of the spillway is also the left retaining wall between the spillway/gate house structure and the left embankment. The right side wall of the spillway is the left support wall of the gate house. The right support wall of the gate house is also the right retaining wall between the spillway/gate house structure and the right embankment.

FIGURE 5. SPILLWAY CREST - PATCHED JOINT

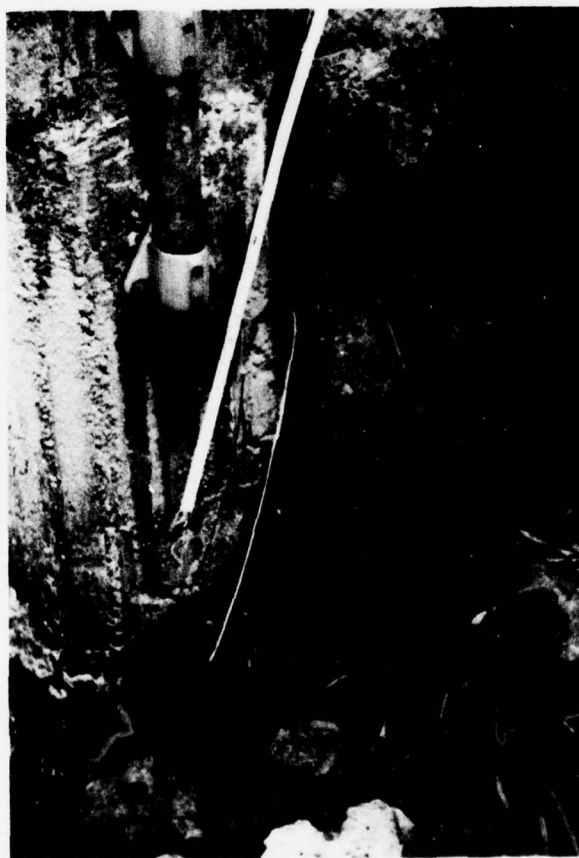
end of the left side wall, immediately adjacent to the embankment (Fig. 6, Appendix D); a moderate amount of seepage was occurring between the wall and the embankment and, from the water stains on the concrete, it appeared that the seepage had been going on for some time.

The right and left retaining walls of the spillway/gate house structure are in generally good condition. The concrete shows signs of minor erosion. As indicated previously, there is a large spall at the base of the downstream end of the left retaining wall (Fig. 6, Appendix D). It is probably due to freezing and thawing

FIGURE 6. SEEPAGE BETWEEN LEFT DOWNSTREAM EMBANKMENT AND SPILLWAY RETAINING WALL

3. All deteriorated concrete on the spillway/gate house structure should be repaired.
4. The source of embankment seepage at the base of the downstream end of the left retaining wall should be determined, and the seepage stopped or controlled.

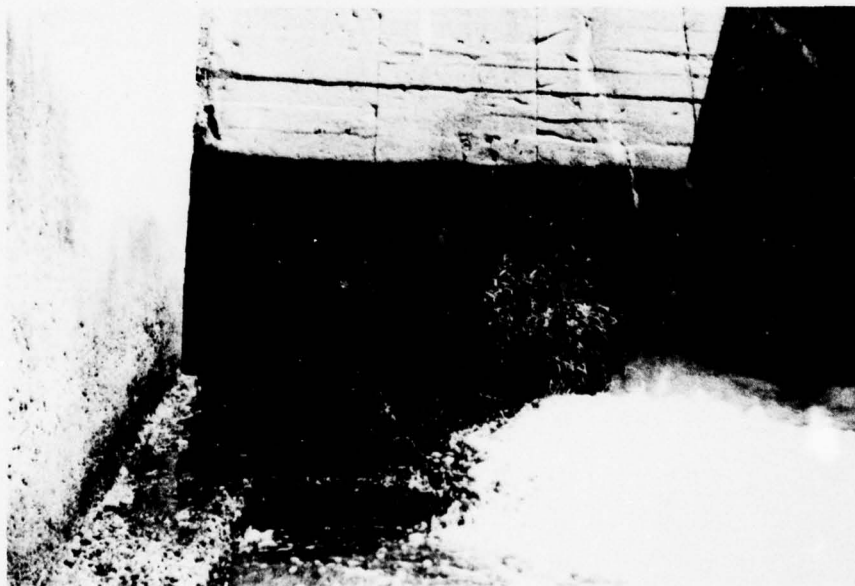
The gate house substructure including the gate portals is in generally good condition. There is some minor erosion of the base slab and right retaining wall footing just downstream of the portal openings (Fig. 10, Appendix D). The massive concrete buttress installed in 1929 is also showing signs of minor cracking and scaling (Fig. 11, Appendix D). The air vent for the right gate was clogged with small debris.

FIGURE 10. GATE HOUSE SUBSTRUCTURE AND GATE PORTALS

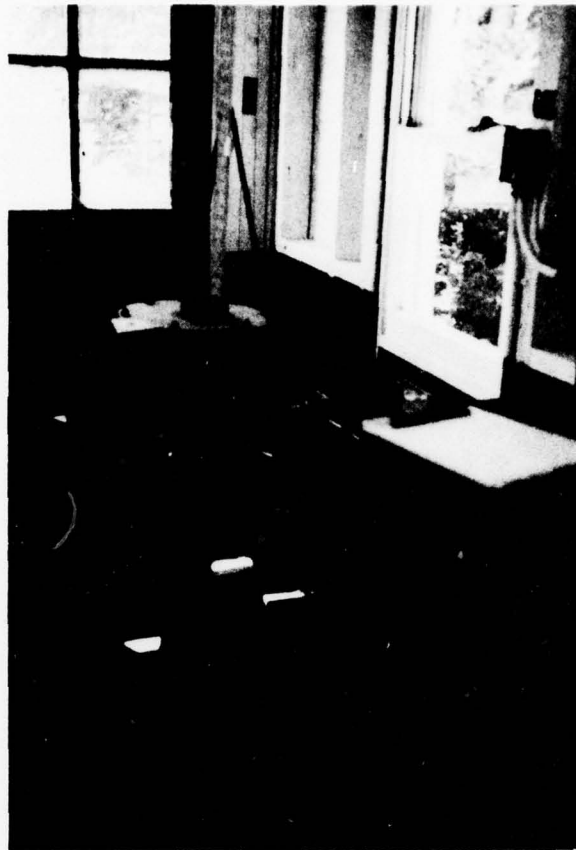
The gate house superstructure is in generally good condition. It is a wood frame structure and has been recently painted. The area around the structure is well maintained and guard rails protect the public from accidentally falling off the retaining walls. No-trespassing signs are clearly displayed (Fig. 12, Appendix D). The interior of the gate house is well lighted and clean. The gate stands are readily accessible and appear to be well maintained (Fig. 13, Appendix D).

FIGURE 13. GATE CONTROL FOR SOUTH GATE

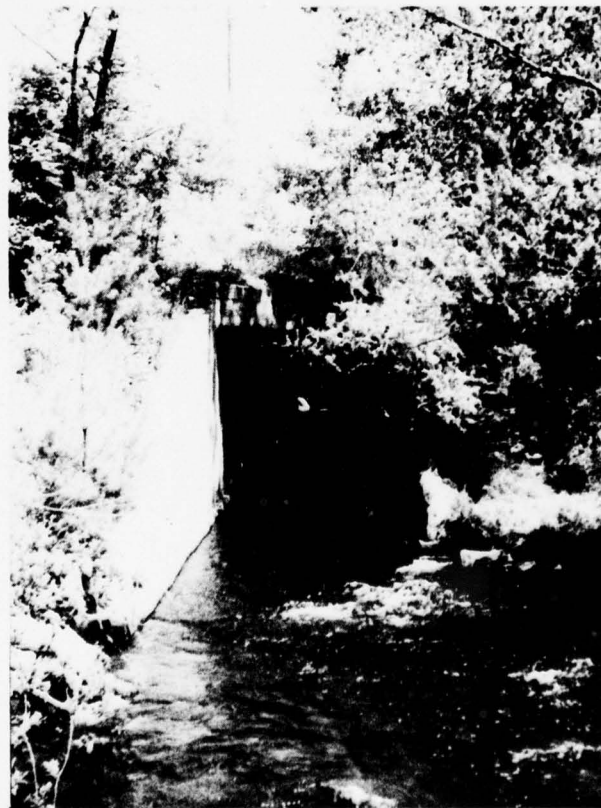
Evaluation of the hydraulic characteristics of the 10-foot by 10-foot concrete box culvert downstream of the dam indicates that it too cannot pass the SDF. Computations in Appendix C show that it has a capacity of approximately 2000 cfs under ten feet of head. This corresponds to 77% of the PMF. Failure of the culvert to pass the PMF would result in overtopping of the State Route 28 embankment and possible flooding of this vital communications link.

FIGURE 16. BOX CULVERT DOWNSTREAM UNDER STATE ROUTE 28
